# FLEXIBILITY

## Helps Contractor Meet Challenges of Grand Canyon Project

Alternative treatment combinations help reduce costs, speed up work and patch more area and allow Intermountain Slurry Seal to meet the original expectations and overall budget of this project

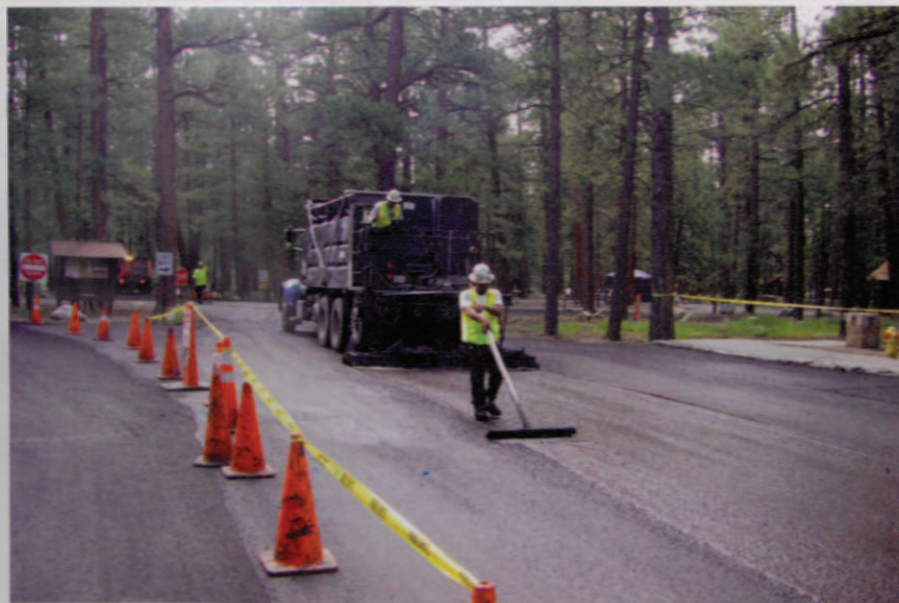
*Most National Parks consider micro surfacing (shown here), slurry surfacing, chip sealing and other pavement preservation processes to be very environmentally friendly.*

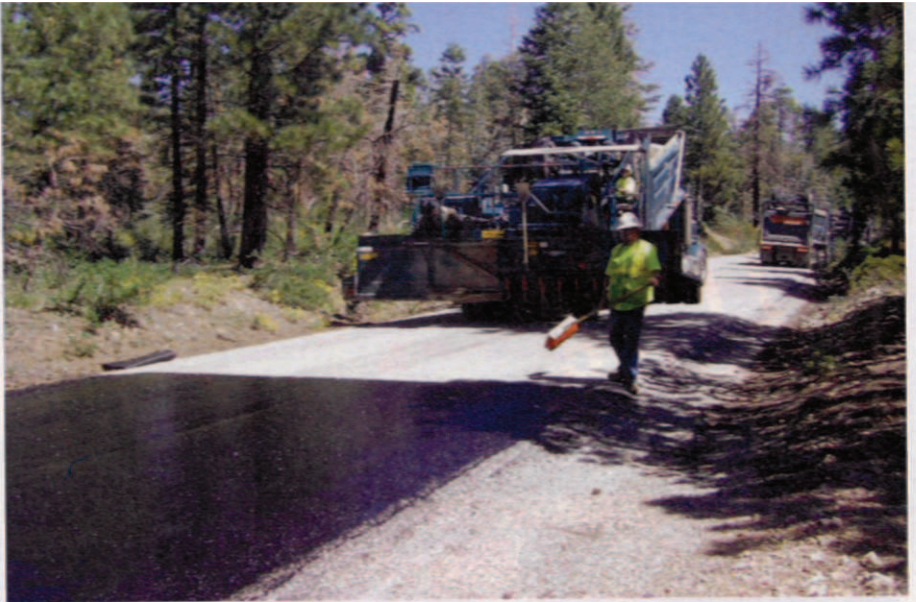
**Narrow roads had to be closed and the chip sealing application modified in order to cover the full width of the road in one pass.**

Like the other processes preceding it, the chip sealing required modification to the original plans, as well as ongoing good communication with the Park Service. For instance, the project plans for the bid indicated that the roads were 22 to 24 feet wide. All of the scenic drives, however, are only 18 to 20 feet wide—consisting of winding, mountainous roads. Intermountain Slurry Seal requested road closures for safety. Although the Park Service preferred not to close roads, management realized it was the only way to keep the public and Intermountain Slurry Seal's employees safe.

The road closures added tremendous pressure to keep the schedule, which had to be published a month in advance of the work and only allowed three days to complete each closed road. In addition, the narrow roads required a modified method for chip sealing application. All of the dump trucks ran in a group from the site to the stockyard in order to cover the full width of the road in one pass. Niemann explains this is because there was no way to allow the trucks to pass around the chipper without moving it off the road, which would have been impossible because of the mountainous terrain and environmental requirements stipulated by the Park Service.

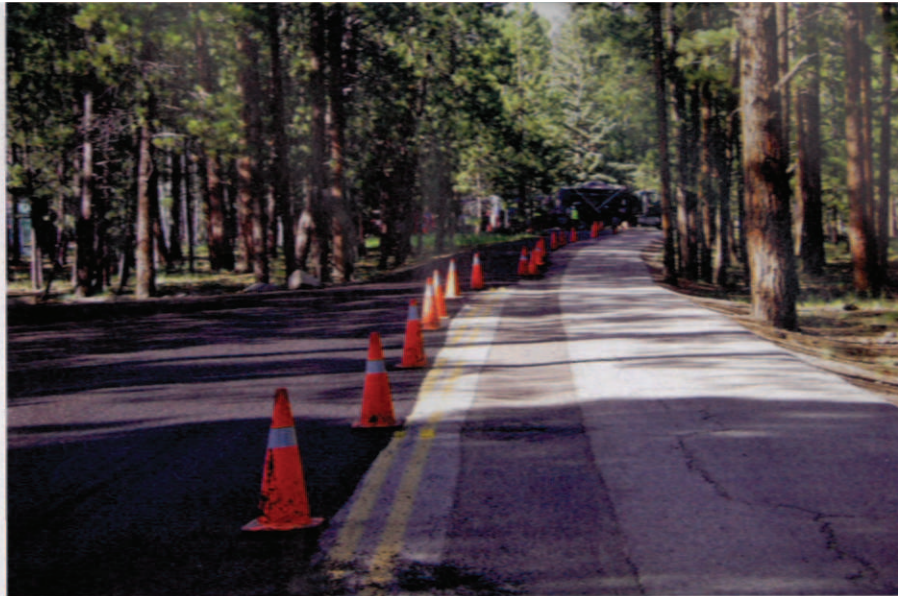
**Long-time staff members estimate that the remote road system leading from Jacob's Lake, AZ, to the North Rim Lodge had received no major maintenance for at least 15 years.**

The remote road system leading from Jacob's Lake, AZ, to the North Rim Lodge had deteriorated to a point that the Federal Highway Association's (FHWA) Central Federal Lands (CFL) Highway Division opted to use ARRA (American Recovery and Reinvestment Act) funds to repair them. No one knew exactly how long it had been since the roads and parking areas had received any real maintenance, but long-time staff members at the park estimate that no major work had been done for at least 15 years — and up to 25 years in some places.

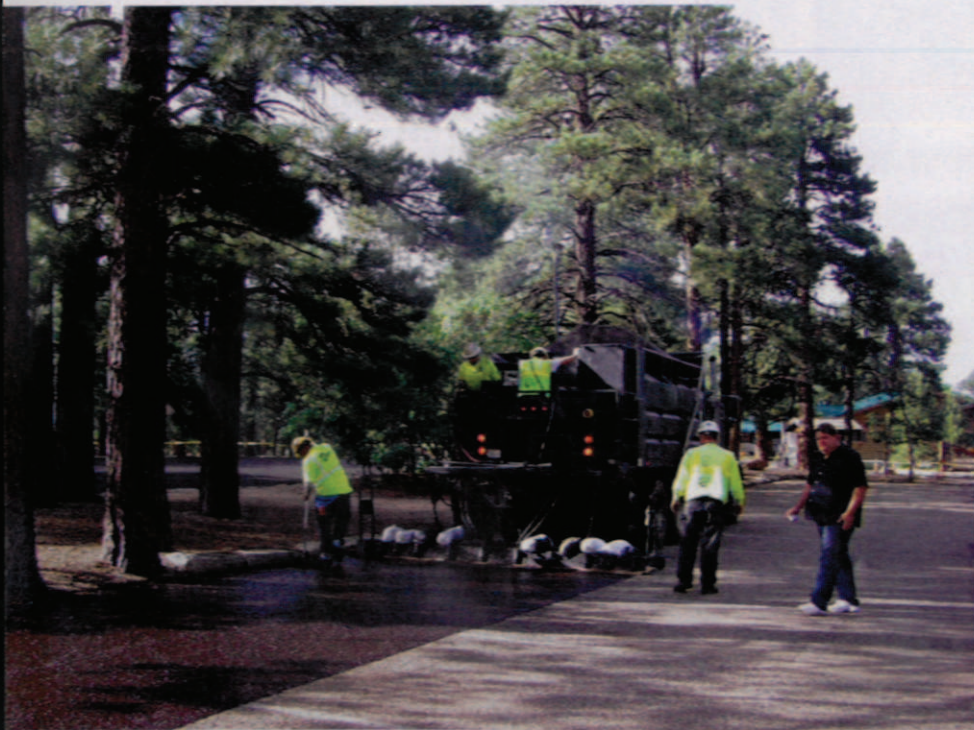
**The flexibility of pavement preservation processes, such as micro surfacing, provides contractors the option to use alternative treatment combinations when job parameters change.**
